BLACK CREEK ENGINEERING FEASIBILITY STUDY

HAMILTON, INDIANA

October 2006

Dynamic Environmental Solutions, Inc.
c/o Doug Mulvey
9226B E. County Highway 3
Newton, IL 62448

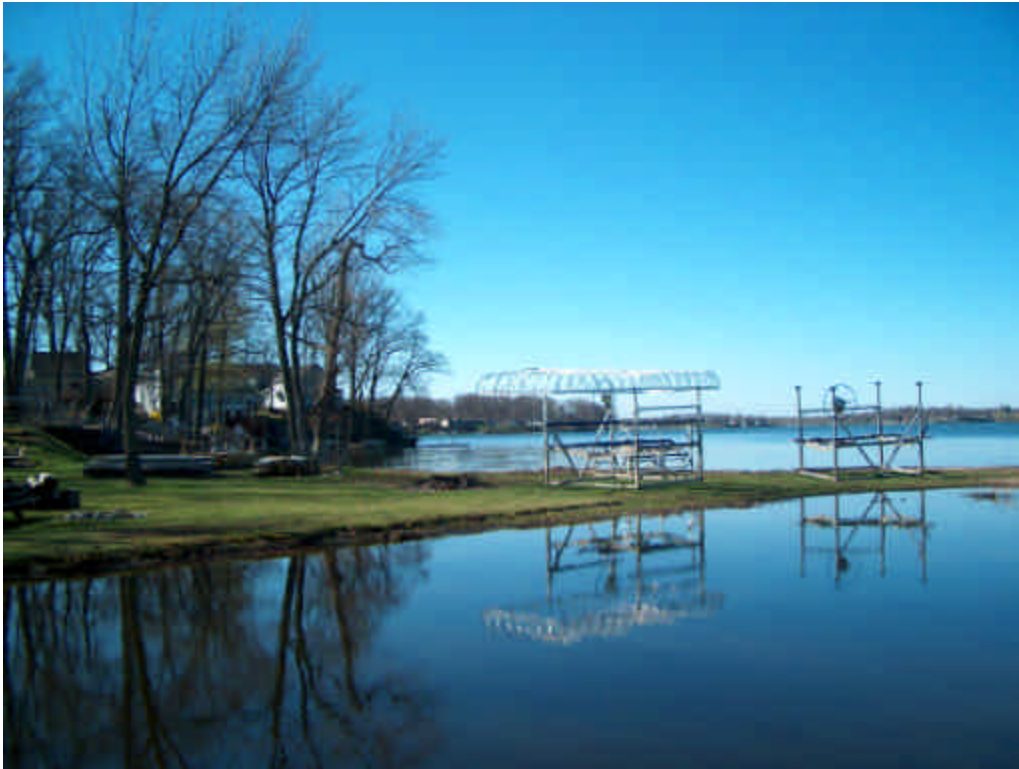
Picture 3: Black Creek at Hamilton Lake (Picture taken Southwest)

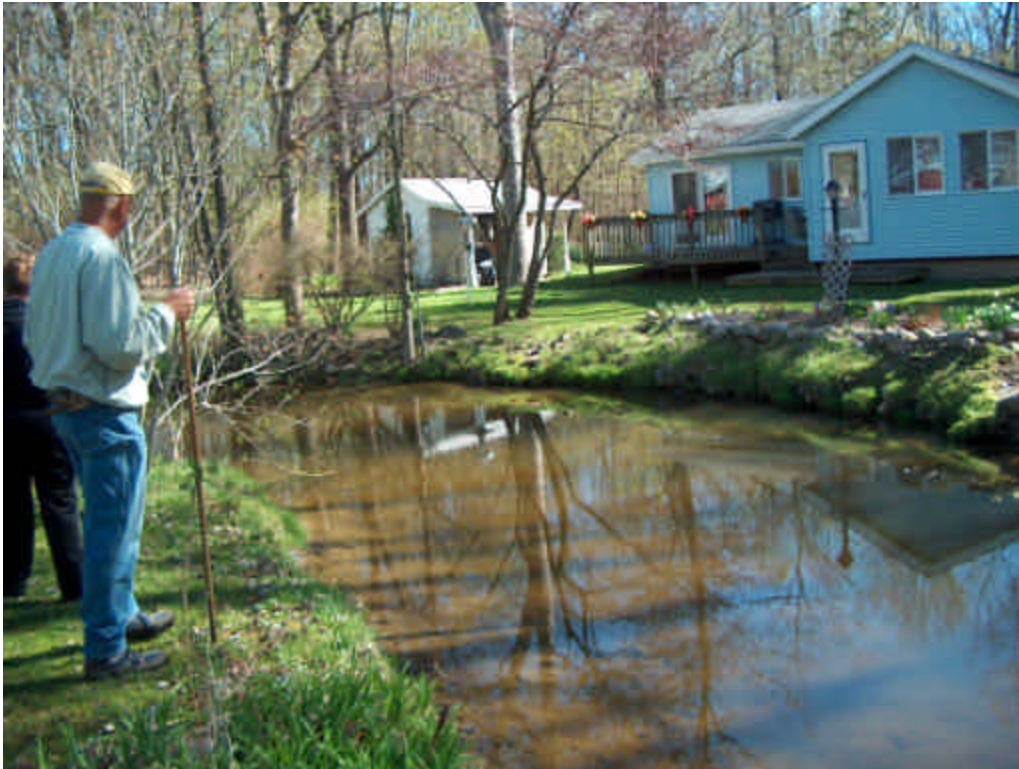
Picture 5: Shoreline erosion and very shallow water from sediment deposition

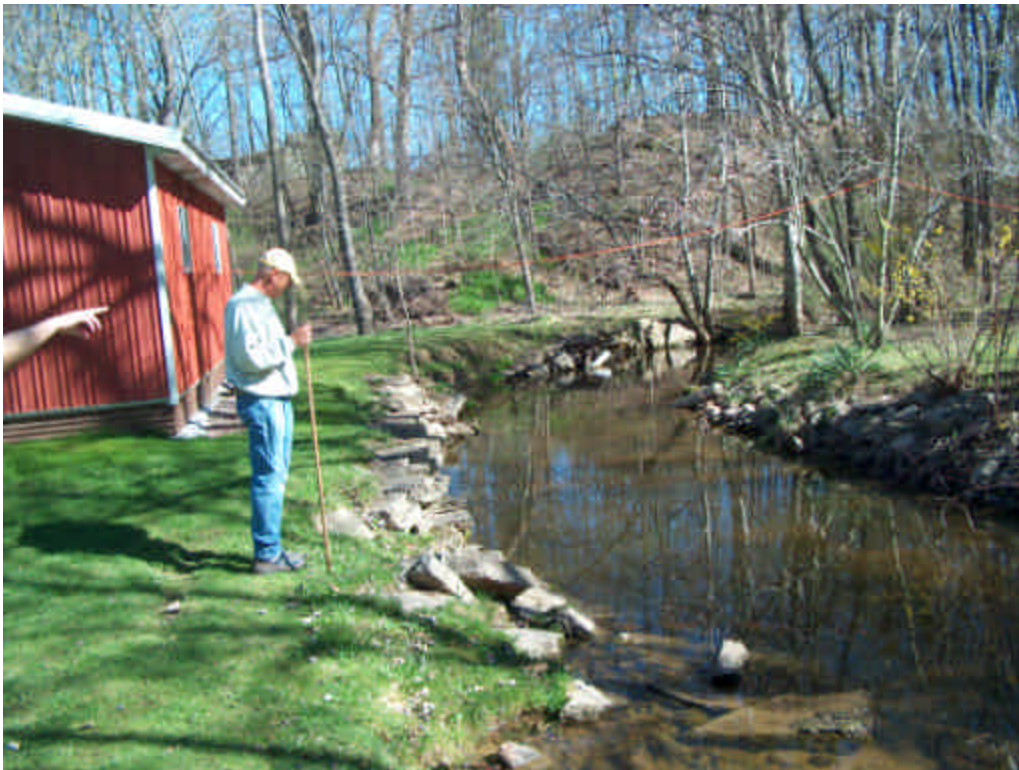
Picture 6: Black Creek makes a 90 degree turn on the Lusch property

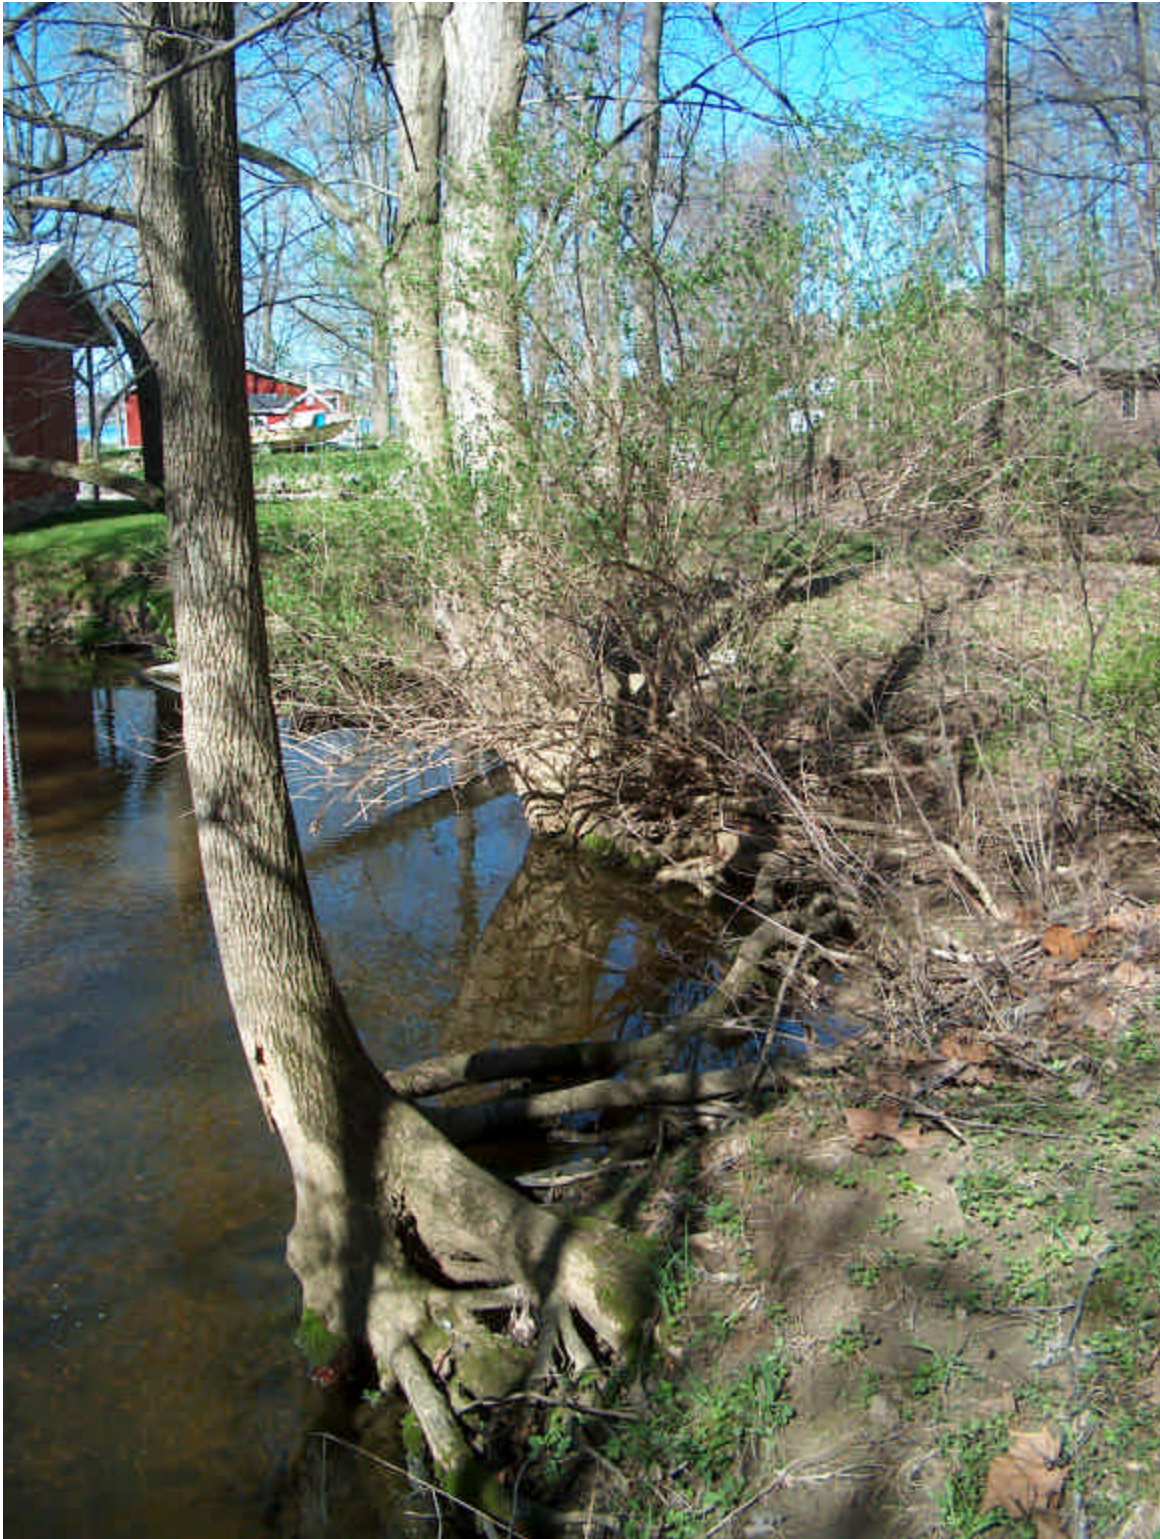
Picture 7: Black Creek makes another 90 degree turn on the Byers property

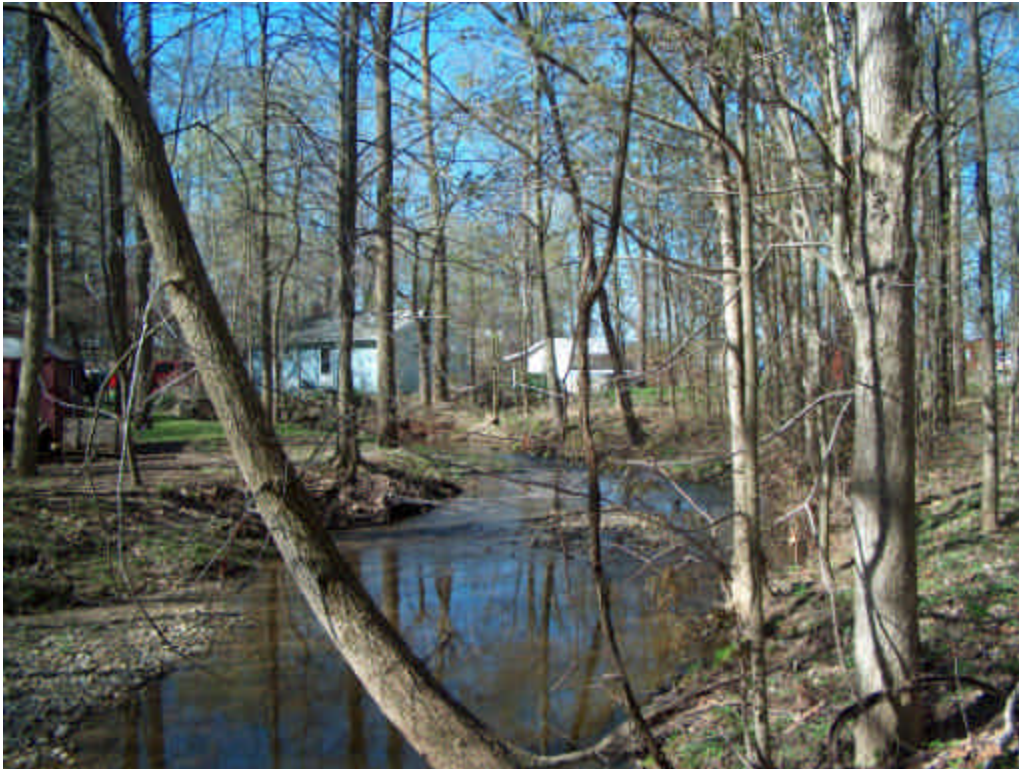
Picture 8: Tree roots providing streambank erosion protection on the Byers property

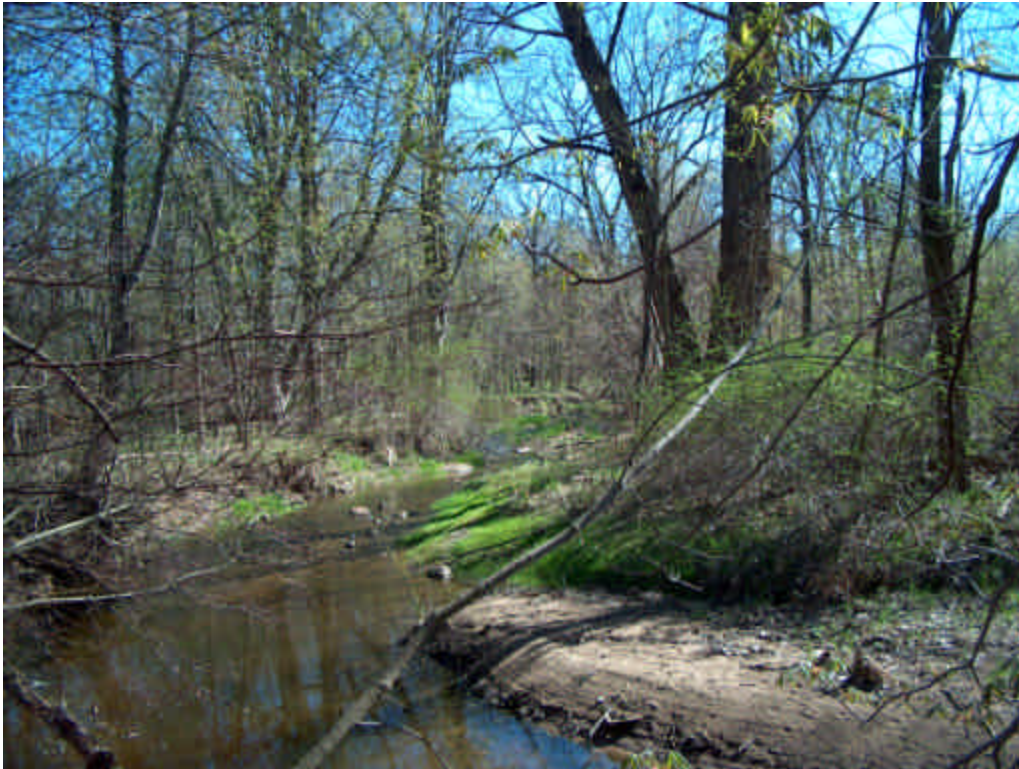
Picture 10: Coarse substrate and pools and riffles along this natural section of Black Creek

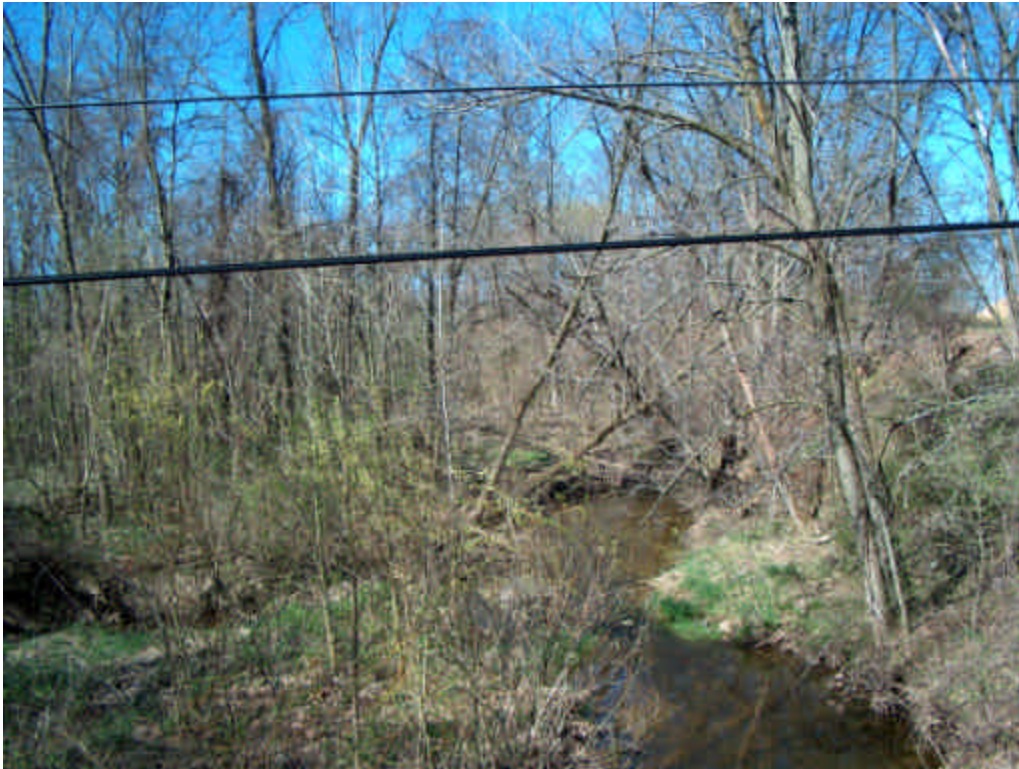
Picture 12: Small stretch of streambank erosion

Farther upstream, near Route 1, is the only other area of significant streambank erosion that was identified in this stretch of Black Creek. This site is on the John Surfus property and is identified in Picture 12 (Appendix B) and location 12 on the Photo Log Location Map – Lower Black Creek – Sheet 1 (Appendix B). If funds are available, this section of stream (approximately 150 feet of the north bank) should be stabilized through vegetative and hard armoring techniques. Sheet 1 in Appendix D details the locations of the proposed improvements.

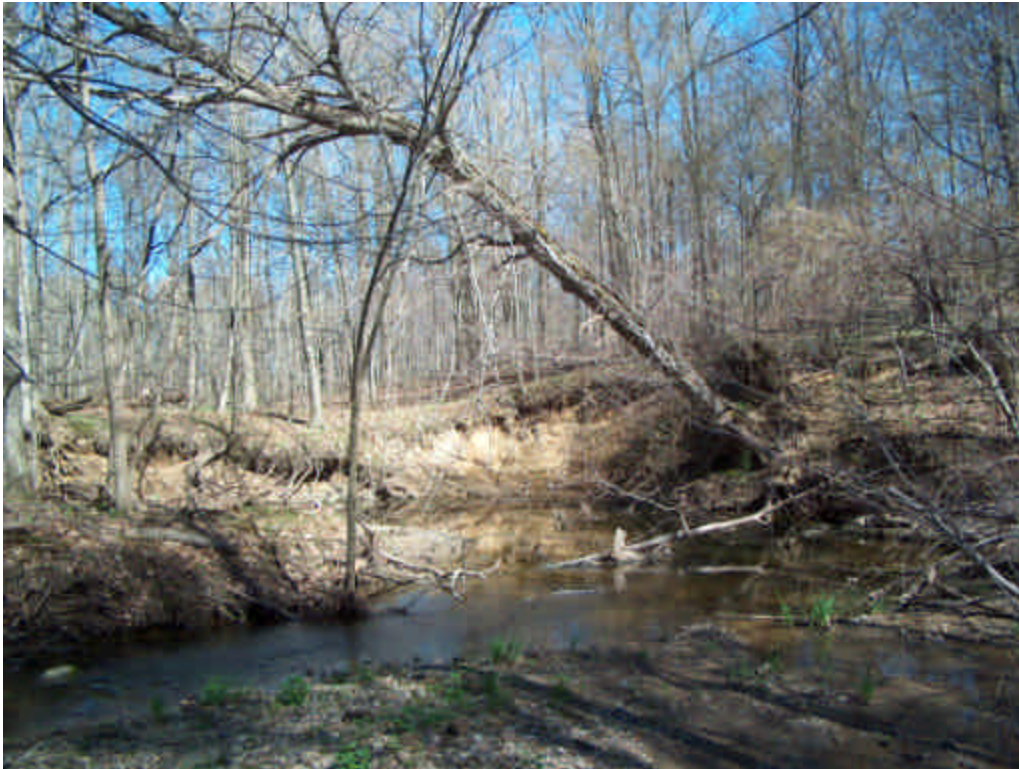
Picture 14: Erosion on "hairpin" bend on the Cold Springs Inc property (upstream view)

Areas to consider for streambank erosion control include those shown in Pictures 14, 15, 18, 22, and 23 (Appendix B). These areas are either located along steep stream bluffs or they are located where the stream does 90 degree or “hairpin” turns. These three discrete locations are located in sections of Black Creek owned by Cold Springs Inc. A small section of Black Creek (Picture 20) shows some erosion along the stream bluff; however, the property owner (Richard Friend) asks that nothing be performed on his property. Sheet 2 in Appendix D details the locations of improvements proposed above.

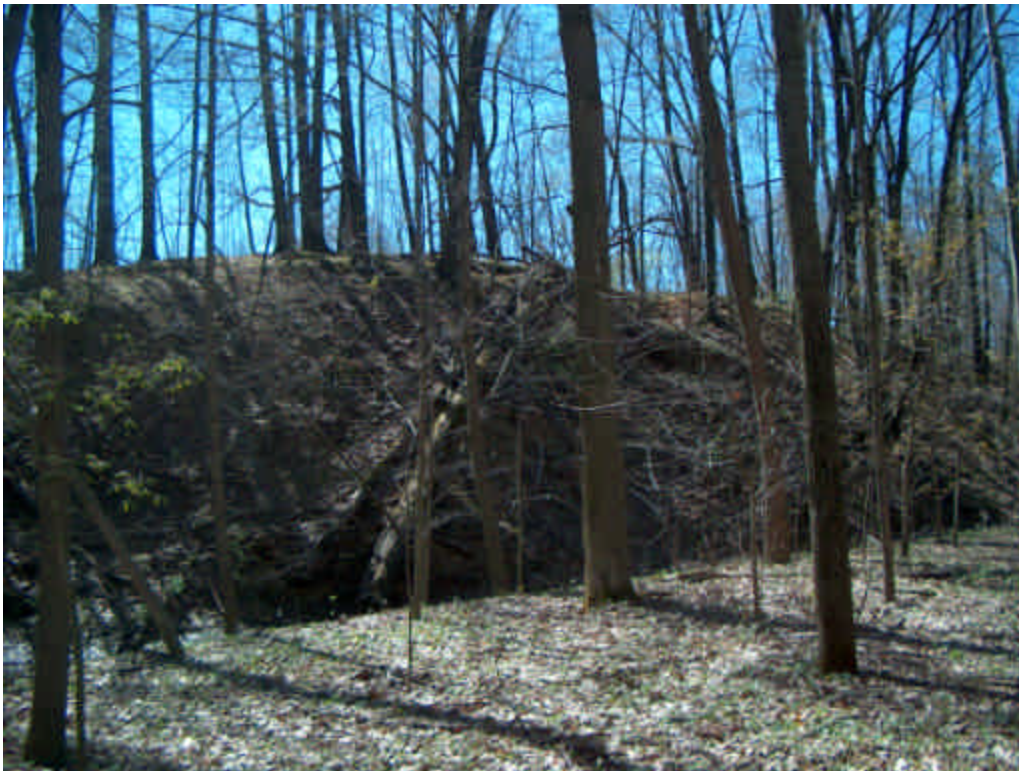
Picture 18: Erosion along the "hairpin" bend on the Cold Springs Inc property oxbow

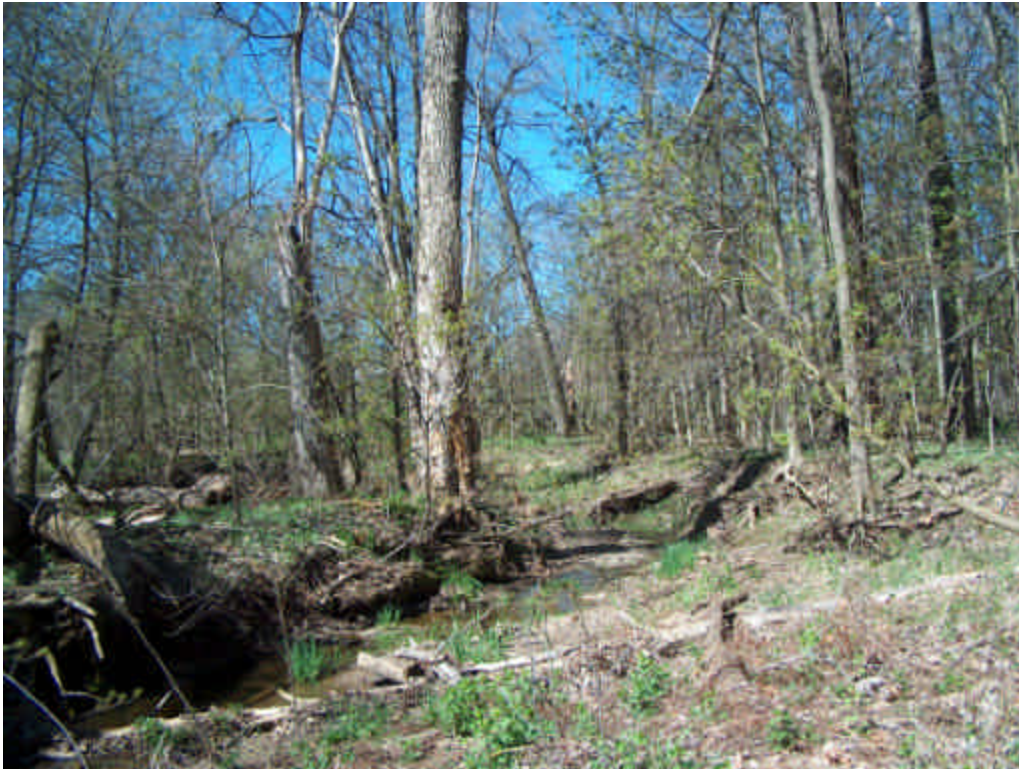
Picture 20: Steep and eroding banks on the Friend property

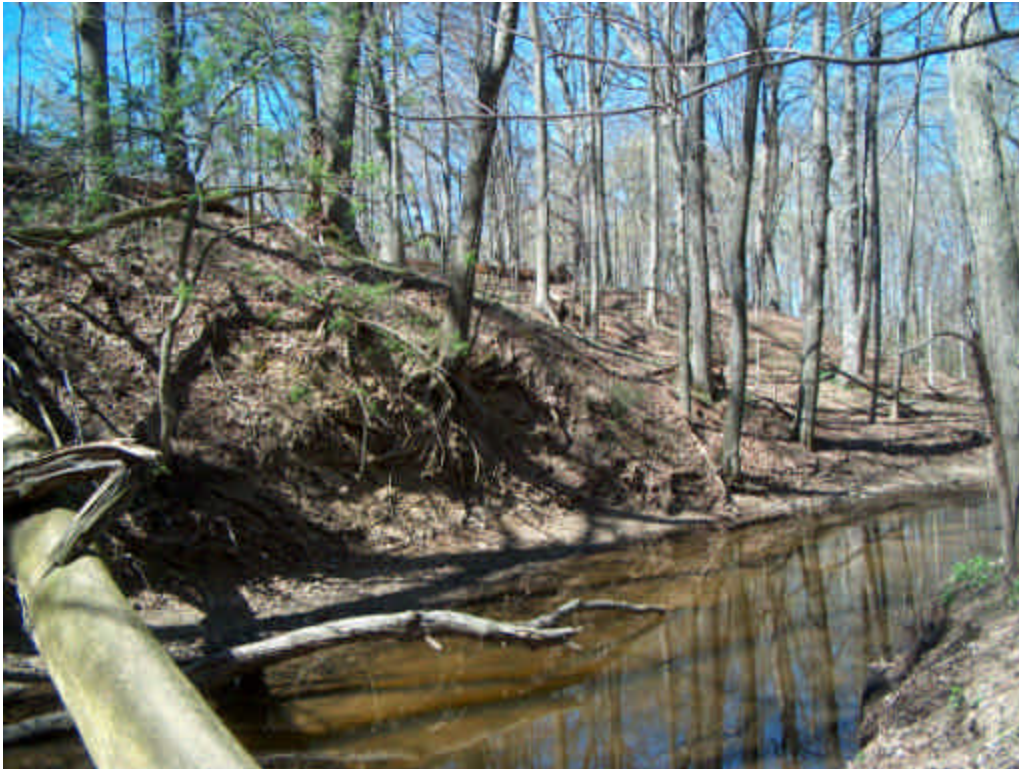
Picture 22: Steep bluffs on 90 degree bend on Cold Springs Inc property

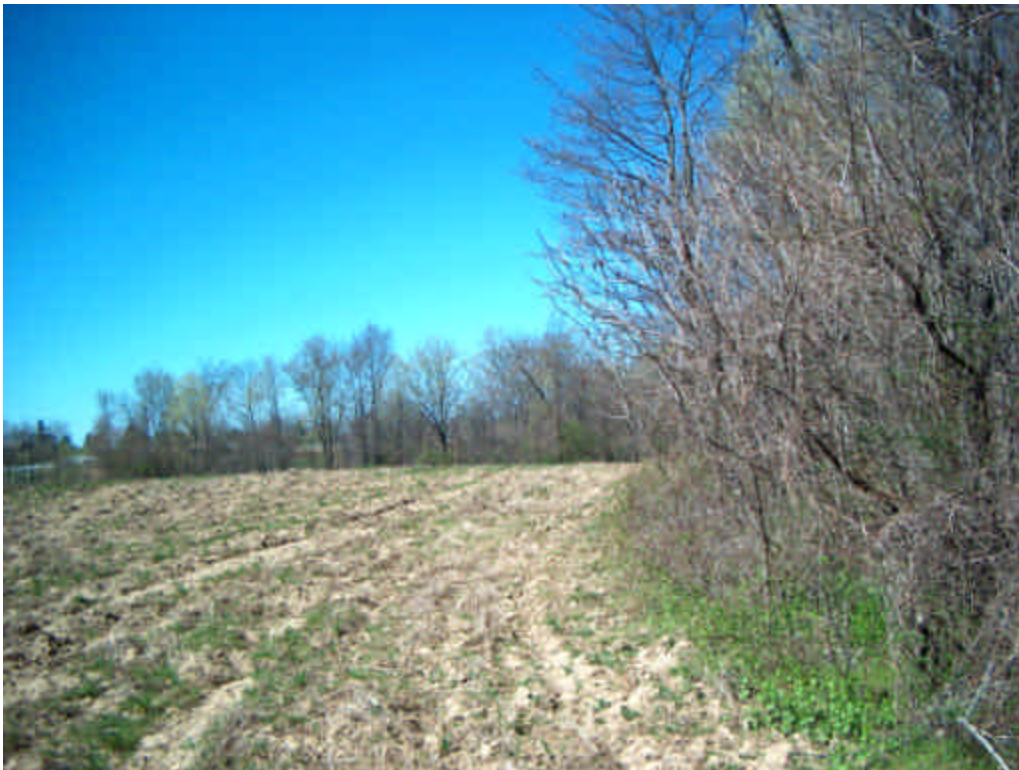
Picture 23: Slight bluff erosion on Cold Springs Inc property

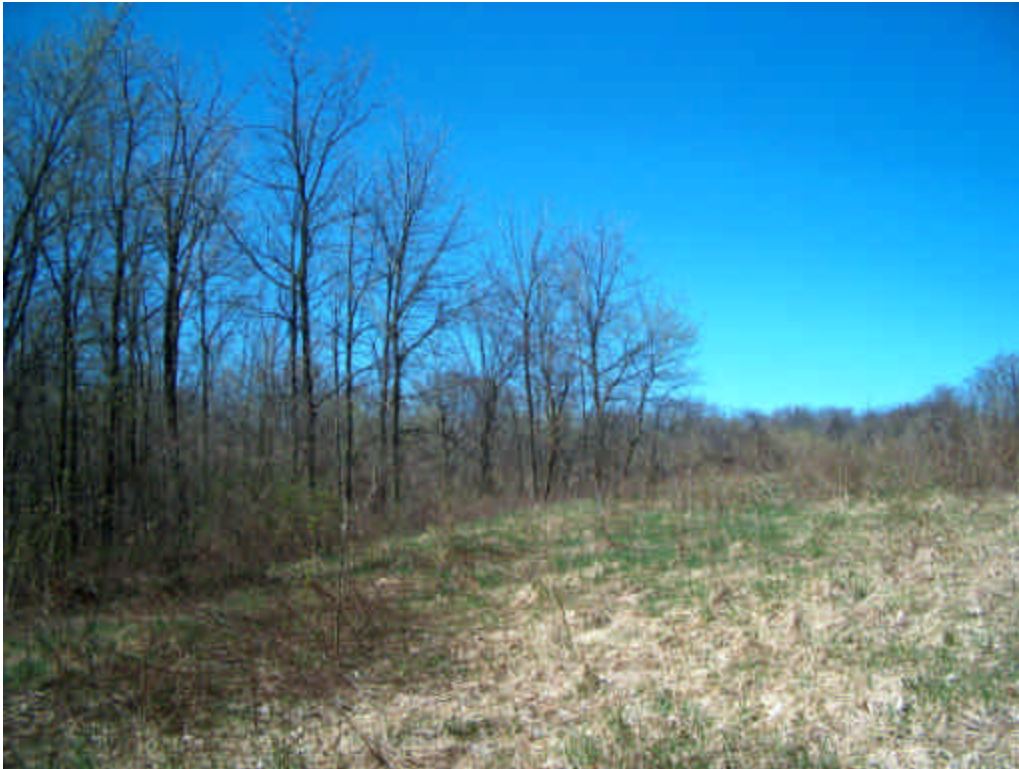
Picture 25: Drainage from Howard fields down bluff into Black Creek

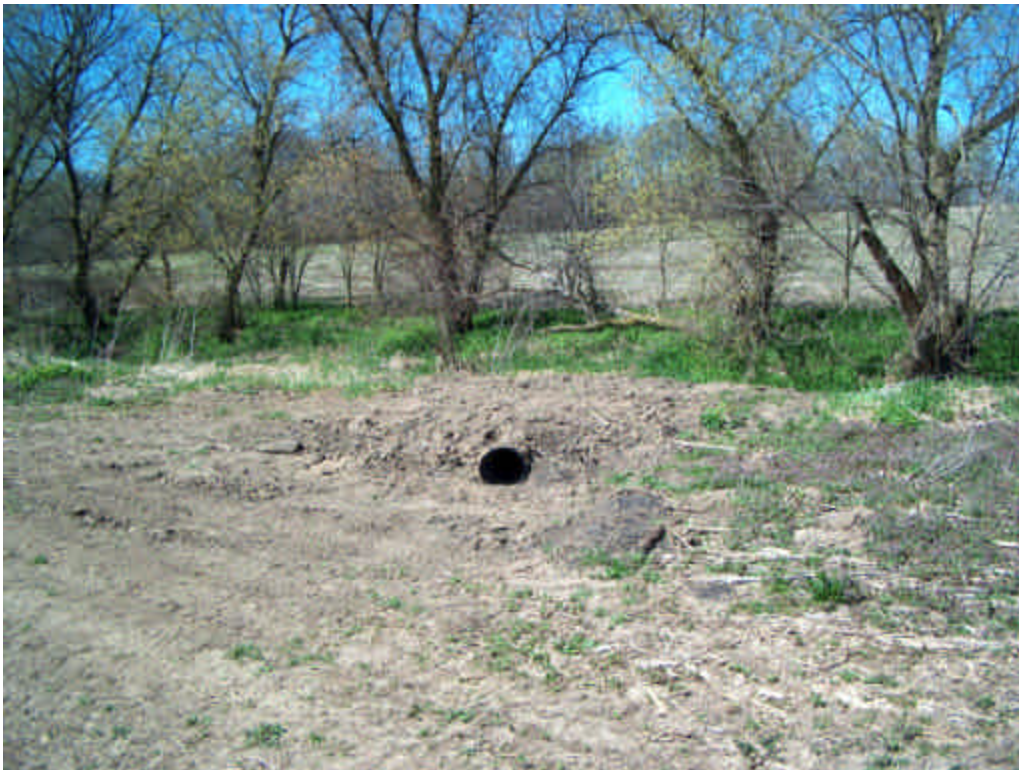
Picture 29: Field drainage of Graft property into Black Creek
